THE CHARACTERIZATION AND ANALYSIS OF ORNAMENTAL  
CAST STONE AND STUCCO FROM THE PALACIO ERRÁZURIZ,  
BUENOS AIRES, ARGENTINA

James Valente Banta

A THESIS

1995

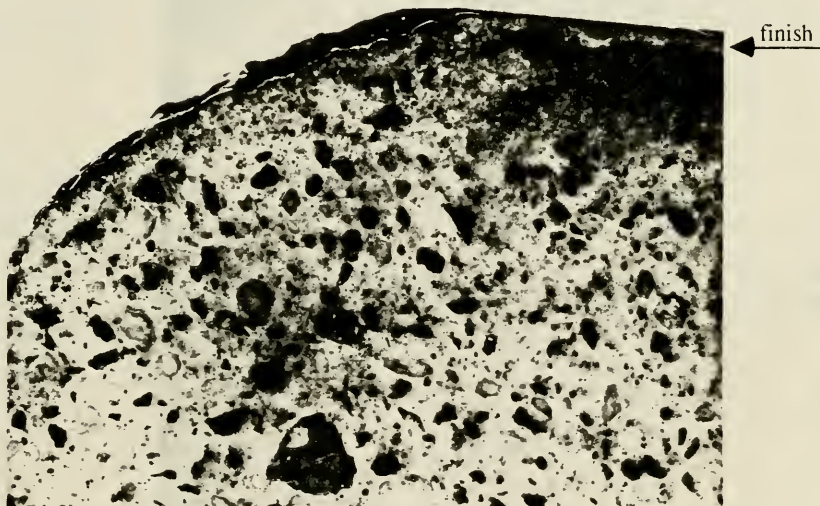
**Material:** Cast Stone  
**Surface Finish:** single thin, fragmentary (white, but soiled)  
**Description:** Single-layer casting

The layer is a light yellow-brown paste (2.5YR 7/4-6/4) that consists of heterogeneous and well graded aggregate. The aggregate is predominantly black translucent subangular grains with translucent, yellow, and amber subrounded grains. The paste contains red, orange, and green/blue colored fines; and vacuoles from the casting process.

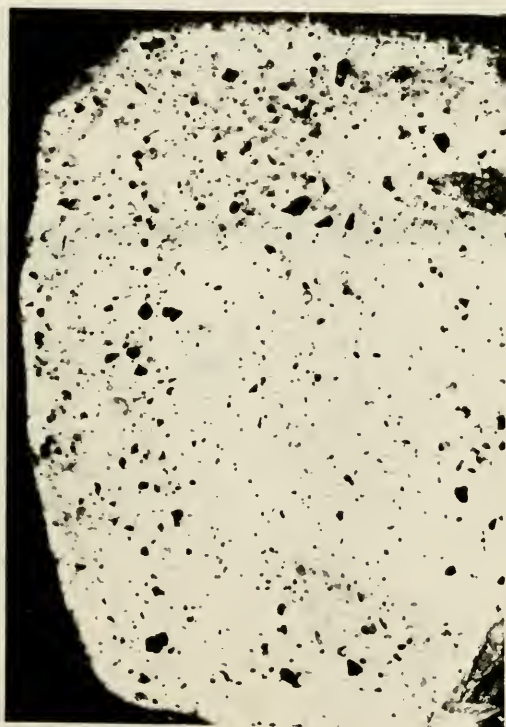
**Description:** Single-layer casting with internal chromatic variation

The matrix consists of an off-white paste (10YR 8/1) with a graded heterogeneous, but mostly fine aggregate. The aggregate is predominantly yellow subangular grains with black subrounded grains. The paste contains red, orange, and green/blue colored fines; and spherical vacuoles. There are 4 or 5 subtle bands of chromatic variation within the sample.

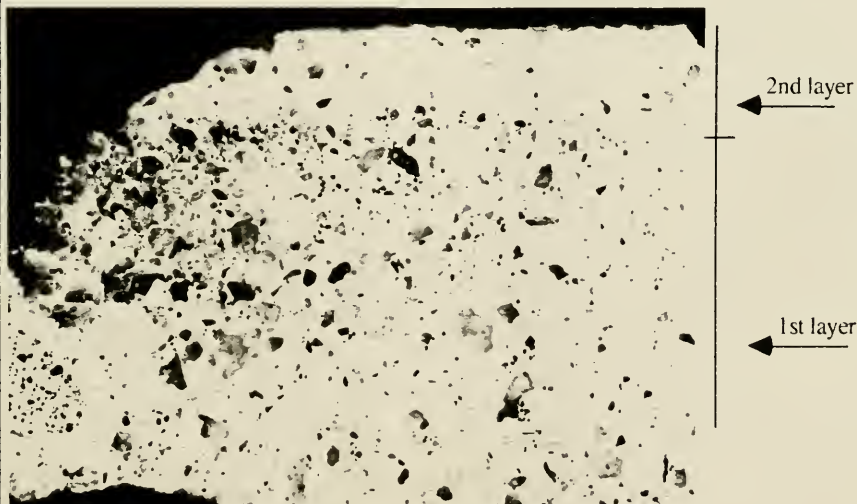
The 1st or base layer has a matrix of a light gray paste (10YR 7/1) with heterogeneous and well graded aggregate. The aggregate is predominantly translucent subangular and subrounded grains with some amber and black subrounded grains. The paste contains red, orange, and green/blue colored fines and a gray composite material. There are vacuoles in the paste that were filled with white polishing powder during sample preparation. This layer is uneven in width.

The 2nd or finish layer has a matrix of a white paste (10YR 8/1) with heterogeneous slightly graded aggregate. The aggregate is predominantly translucent subangular and subrounded grains with some amber subrounded grains. The paste contains a small amount of red and orange colored fines. This layer is even and distinct and measures 2 mm in width.

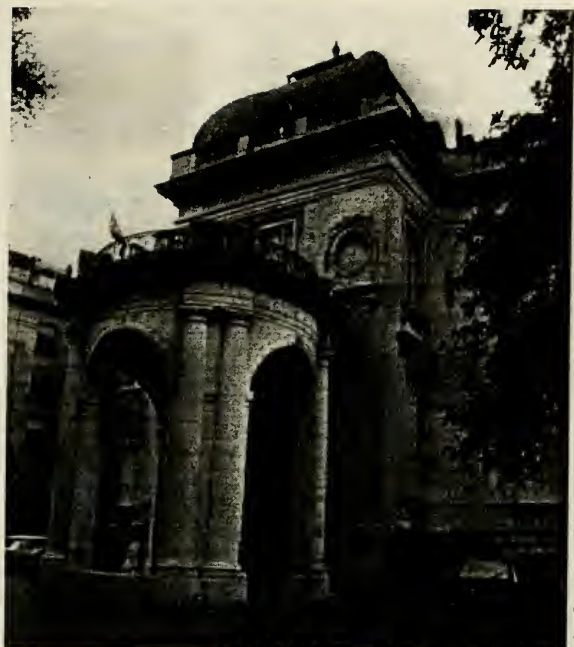
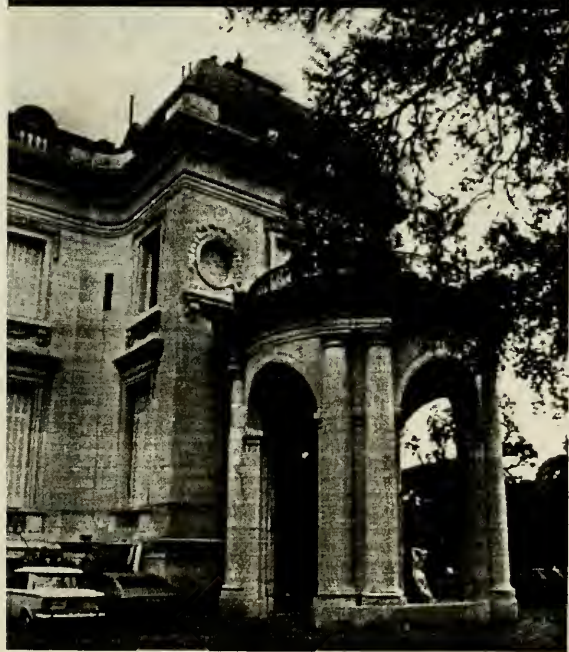
The tholos of the east entrance is over-painted up to the cornice. As this facade is in the worst condition, removal of the over paint will likely expose bad repairs as well as deterioration and damage. Test treatments are recommended for steam, abrasive, and

chemical paint stripping and cleaning of the entrance. The conditions visible now are abrasion and impact loss, delamination and scaling, as well as irregular loss of partial paint layers due to water penetration.

Illustration 7. Palacio Errazuriz,  
east entrance and porte-cochere  
(view from the northeast).

Illustration 8. Palacio Errazuriz,  
east entrance and porte-cochere  
(view from the southeast).

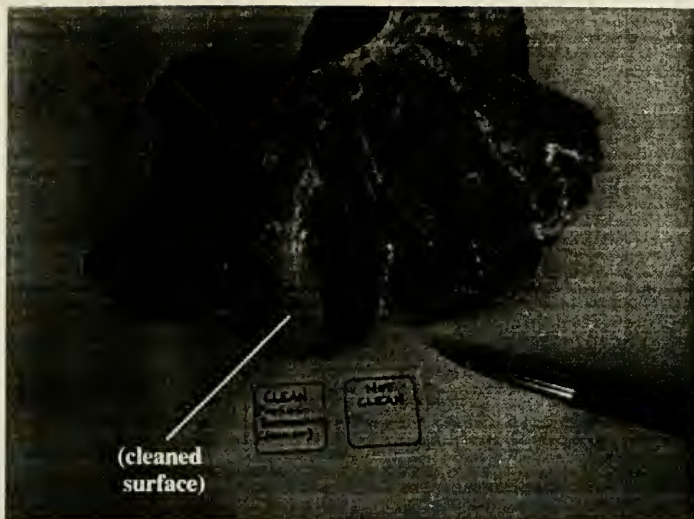
The original appearance of the building has changed with time and it appears that the cast stone elements have generally darkened. This is most likely due to soiling from atmospheric pollution and organic staining. Cleaning tests on samples reveal a surface appearance that more closely resembles the natural limestone on the building. (see Illustration 12)

Illustration 12. Soiled cast stone cornice rosette partially cleaned with ProSoCo Heavy Duty Restoration Cleaner (1:5) showing a surface close to the original appearance.

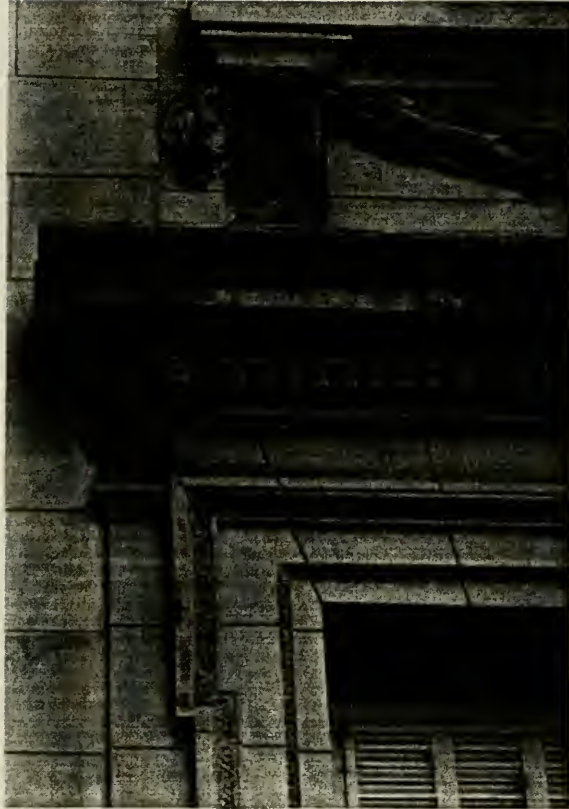
There is evident corrosion of the reinforcing bars that are embedded within the cast stone. (see Illustration 14) Another factor that has led to the deterioration of the cast stone elements may be freeze-thaw cycling.

Illustration 14. Palacio Errazuriz, cast stone loss and exposed reinforcing bars, east facade. Photo by Fabio Grementieri.

For cracks with exposed reinforcing bars, the same preparation outlined above should be carried out. After stabilizing the surrounding cracked cast stone with facings as described above, the exposed reinforcing bar should be mechanically cleaned with an air-

pressurized micro abrasive. All flaking and corroding metal should be mechanically removed, the surfaces degreased, and an epoxy primer, such as Sikadur 22, should then be applied to the remaining metal. For elements requiring additional or replacement reinforcement due to corrosion, new stainless steel and/or threaded nylon rods of appropriate diameter should be installed in combination with an epoxy adhesive such as Sikadur 30. After being treated, all cracks and losses should be filled and finished to match the existing cast stone with a composite mortar repair similar to the original in color, texture, and weatherability.

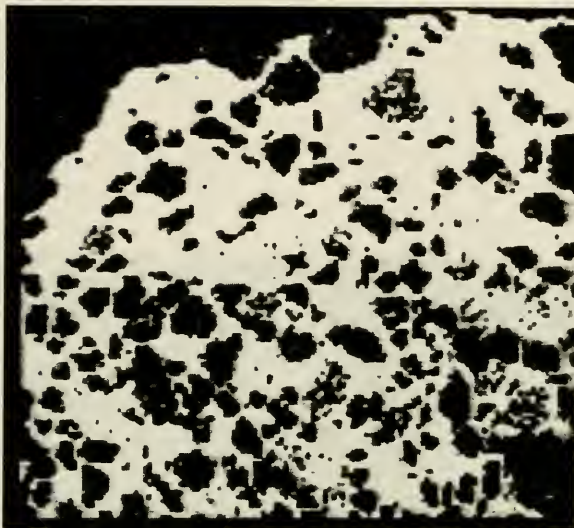
Illustration 17. Sample ER 28, SEM/EDX calcium mapping in cross section. Highlighted areas indicate calcium-rich binder paste.

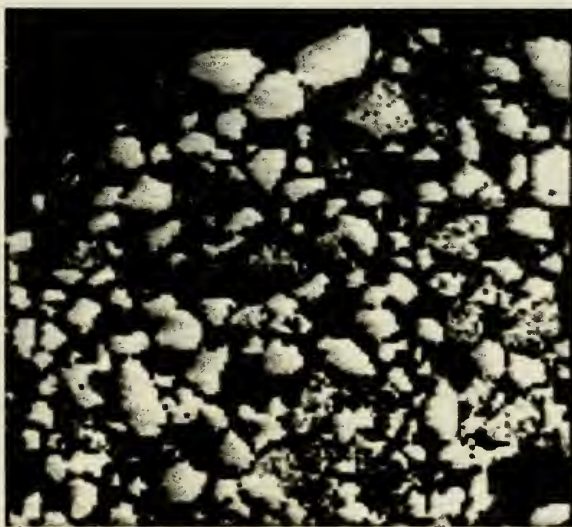
Illustration 18. Sample ER 28, SEM/EDX silicon mapping in cross section. Highlighted areas indicate silicon-rich aggregate.

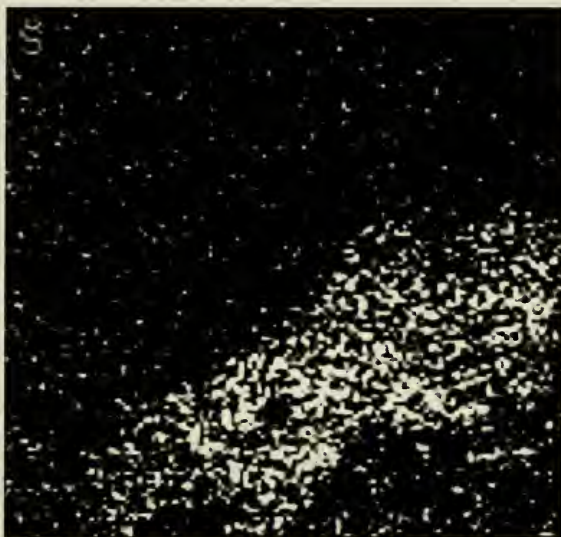
Elemental composition was easily visualized by mapping various elements with the Energy Dispersive X-Ray Analyzer (EDX) coupled with the SEM. Several elements were identified within the paste such as calcium and silicon. (see Illustrations 17 and 18) Iron was scanned in order to determine the presence of iron-based pigments and whether or not the observed internal discoloration was related to iron staining. Magnesium and aluminum were scanned because they are definite components of cement and may provide some information regarding the cast stone mixtures. Chlorine was scanned as a contaminant salt that would be expected in a marine environment such as Buenos Aires. Sulfur was scanned because it is indicative of sulfate crusts associated with atmospheric pollution, or a possible gypsum finish layer, or the presence of gypsum as an additive in the mixture. The strong presence of sulfur identified within the white band in sample ER 2 is likely to be gypsum used as an additive. (see Illustration 20)

Illustration 19. Sample ER 2, SEM/EDX sulfur mapping of core showing internal sulfur-rich zone suggesting the presence of a gypsum admixture.

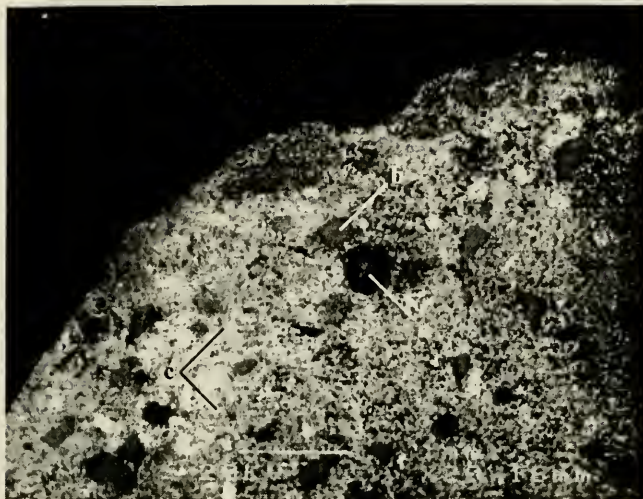
Illustration 20. Sample ER 1, SEM/EDX back scatter electron image in cross section. Note vacuole from casting process (a), aggregate (b), and paste (c).

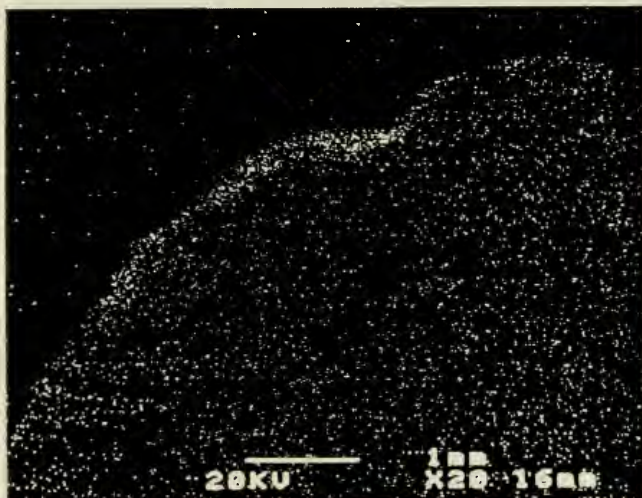
The presence of a sulfur rich crust on samples ER 1 and ER 2 probably indicates the effects of pollution. (see Illustrations 20, 21, 22, and 23) Sulfur in the atmosphere from industrial production combines with moisture in the atmosphere to react with carbonate-rich masonry and forms sulfate crusts. These sulfur-rich surface layers may also be evidence of a gypsum (calcium sulfate) finish or the presence of bacterial action, but the location from which samples ER 1 and ER 2 were taken suggest another theory.

Illustration 21. Sample ER 1, SEM/EDX sulfur mapping in cross section showing sulfur-rich surface.

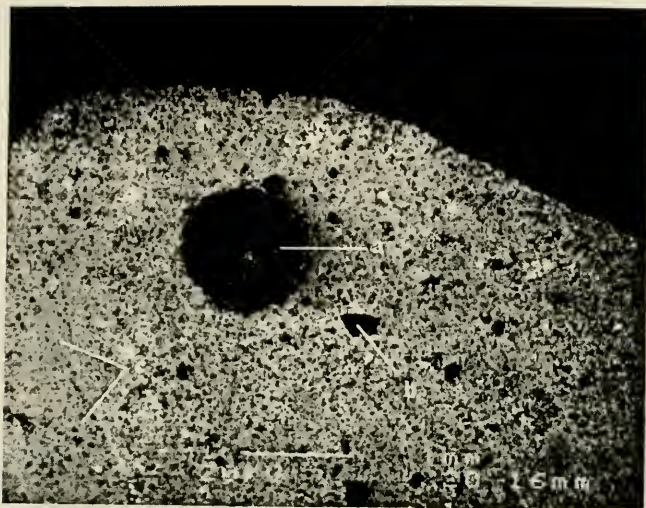
Illustration 22. Sample ER 2, SEM/EDX back scatter electron image in cross section. Note large vacuole from casting process (a), aggregate (b), and paste (c).

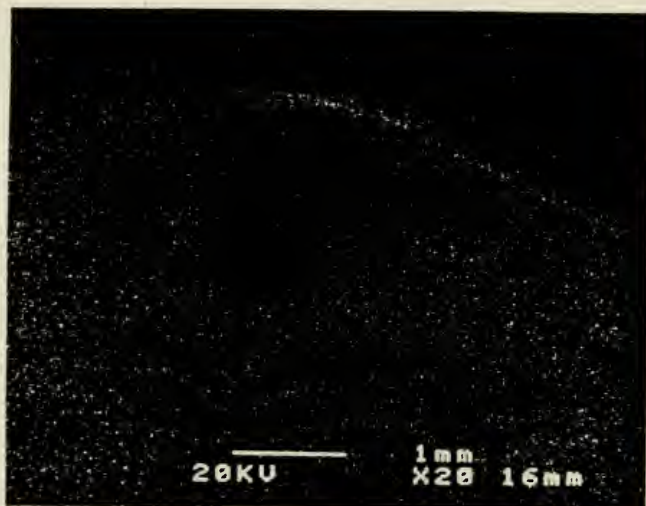
Illustration 23. Sample ER 2, SEM/EDX sulfur mapping in cross section showing sulfur-rich surface.

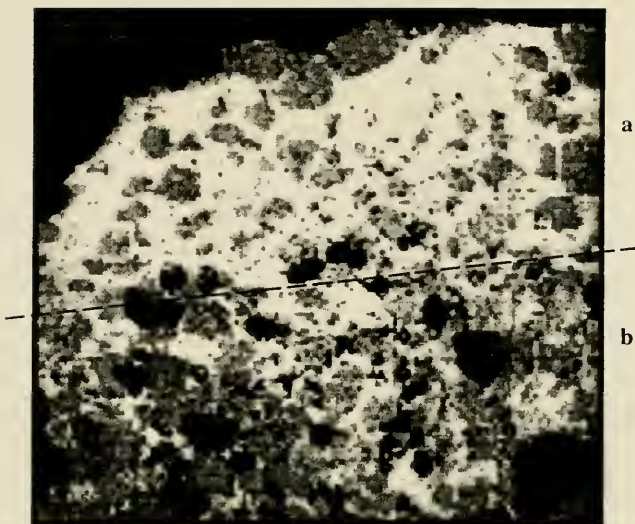
Illustration 24. Sample ER 28, SEM/EDX back scatter electron image in cross section. Note the finish layer (a) and the base coat (b) of the stucco.
